# Plasma cleaning of carbon films for transmission electron microscopy

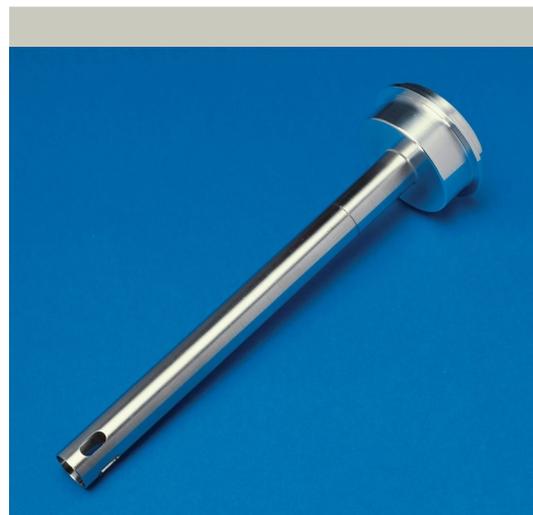
**FIGURE 1.**  
Shielded specimen holder port.

To slow the degradation rate within the Ar-25% O<sub>2</sub> inductively coupled plasma of the Model 1020 Plasma Cleaner, Fischione Instruments designed a shielded holder port. The shield reduces the plasma density by reducing the cross-sectional area available to the plasma near the holder tip. The shield provides an electrically grounded surface that is concentric with the holder geometry, Figure 1.

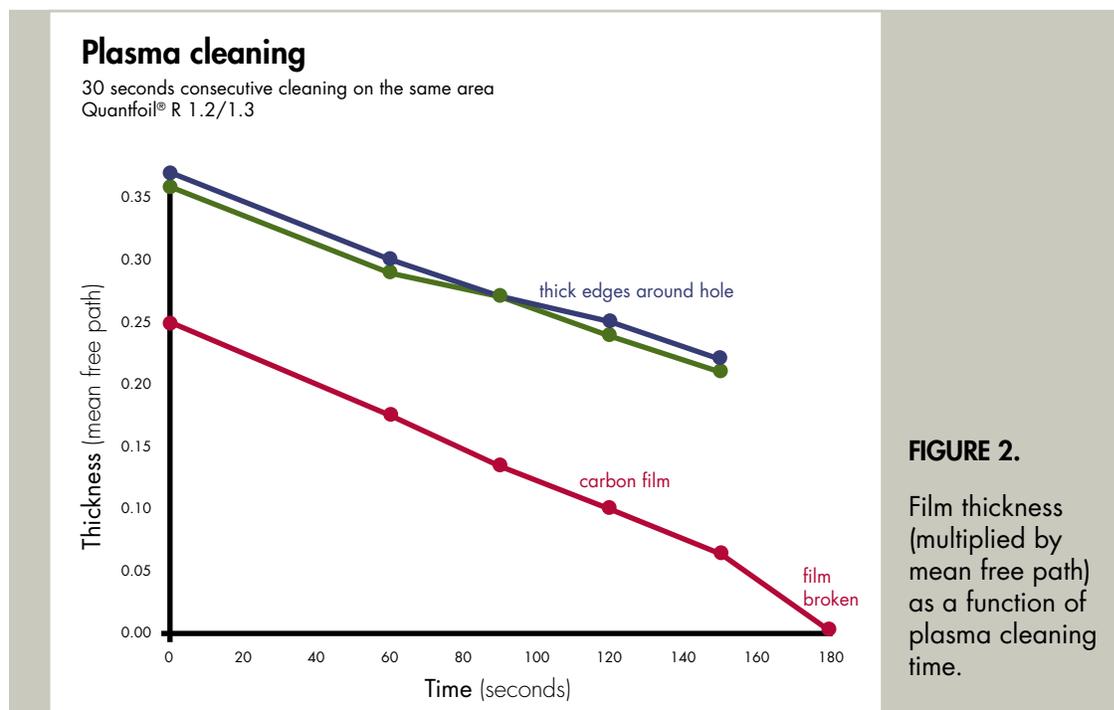
**FIGURE 2.**  
Film thickness (multiplied by mean free path) as a function of plasma cleaning time.

When a support film was cleaned for 30 seconds in consecutive steps and analyzed, electron energy loss spectroscopy (EELS) data was generated as shown in Figure 2. The experiment was ended when the support film was observed to rupture in the FEI CM30 transmission electron microscope. Using a value of 110 nm for the inelastic mean free path (MFP) for carbon at 200 kV, the degradation rate for the carbon film is 7.9 nm/min. After 6 minutes (360 seconds) of plasma cleaning, the film could still be imaged and without recontamination.

determined as 15.7 nm/min. With the shield, this rate decreased to 2.6 nm/min. In practical terms, the shield expanded the time window for plasma cleaning from less than 2 to more than 10 minutes.

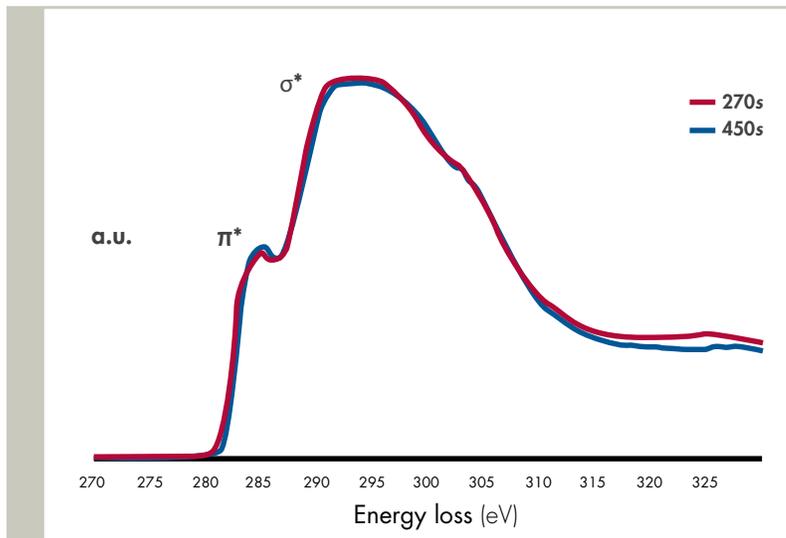
**FIGURE 3.**

Amorphous film, carbon K-edge spectra after 270s and 450s of plasma cleaning with the shield. The relative heights of the peaks are constant.

EELS was performed on an amorphous carbon film at selected times of plasma cleaning with the shield to determine any change of structure of the film as it was slowly thinned. The carbon K-edge spectrum (above 285 eV of energy loss) shows the transition from the  $1s$  occupied electronic state to the unoccupied states above the Fermi level.

The first two peaks represent the transitions to the  $\sigma^*$  and  $\pi^*$  unoccupied states. These proved constant as Figure 3 shows. The structure of the film is unchanged when plasma cleaned, while no contamination during imaging indicates effective plasma cleaning.
